Manhole Inspection Summary

Manhole # S33II1024MH

Insp Date: **6/26/08 8:50 AM**

Location Address: **4210 CHARLES ST**

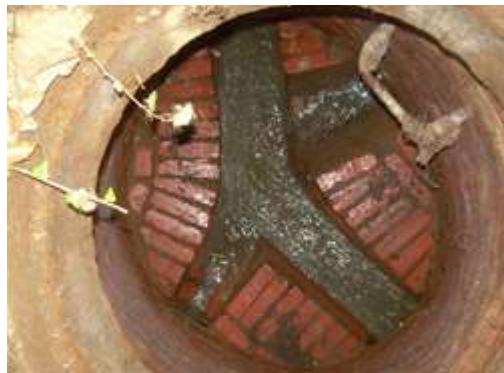
Top View

Corroded steps. Evidence of surcharge - Bench debris. Channel debris.

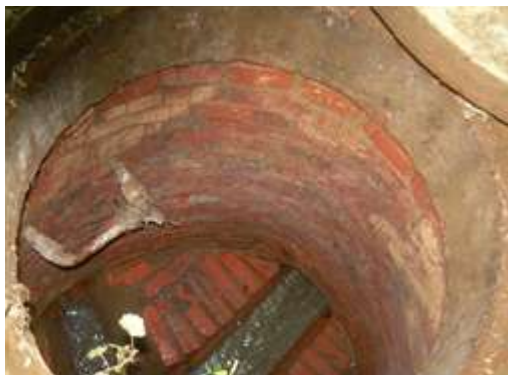
Defect

Frame leaks. Corbel root intrusion and infiltration. Barrel infiltration - other side.

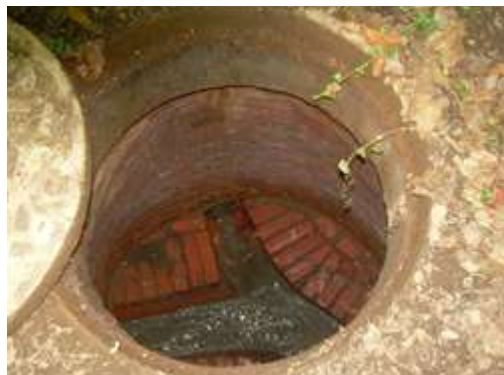
Defect

Frame leaks. Corbel root intrusion and infiltration. Barrel infiltration.

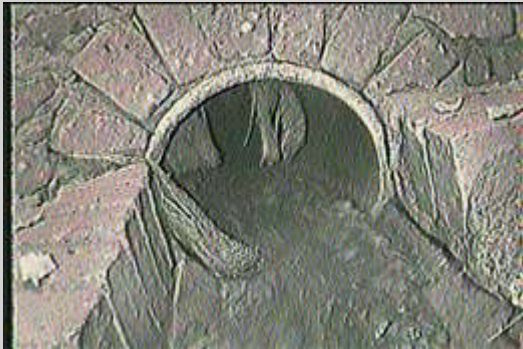
10 in. Circular Gravity Sewer Pipe Out @ 12 O'Clock

Channel deterioration and root intrusion.

Infiltration: **None** Pipe Seal Cond: **Roots**

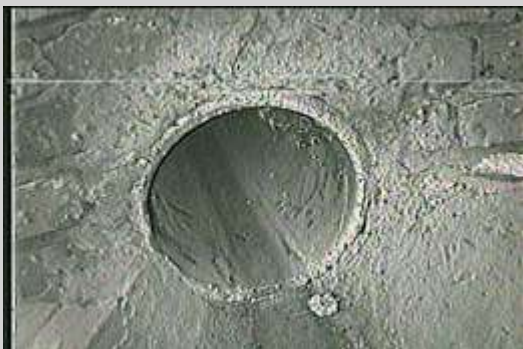
8 in. Circular Gravity Sewer Pipe In @ 3 O'Clock

Infiltration: **Evidence** Pipe Seal Cond: **Cracked**

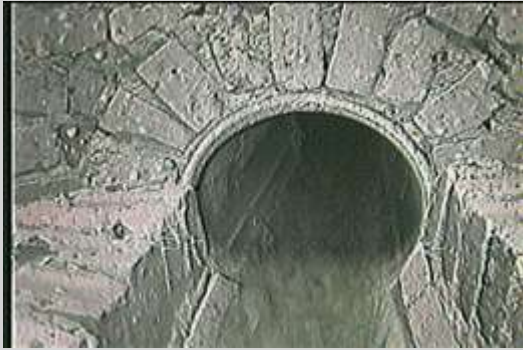
Pipe In @ 5 O'Clock

Barrel deterioration and infiltration.

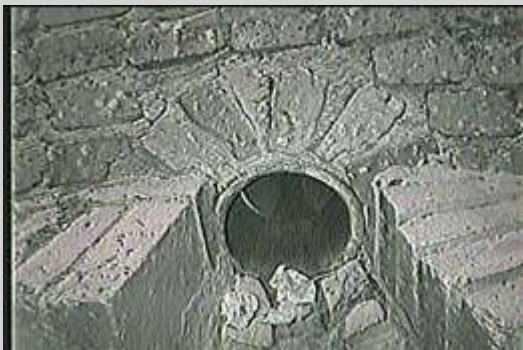
Pipe In @ 7 O'Clock

Infiltration: **Evidence** Pipe Seal Cond: **Cracked**
